THERMAL INTEGRITY PROFILING ACCELERATES CONSTRUCTION OF RAILROAD PROJECTS

Travis Coleman, P.E.
GRL Engineers
1540 E. Dundee Road #102
Palatine, IL
(847) 221-2750
tcoleman@grlengineers.com

Daniel Belardo
GRL Engineers
30725 Aurora Road
Solon, OH
(216) 831-6131
dbelardo@grlengineers.com

Thermal Integrity Profiling Accelerates Construction of Railroad Projects

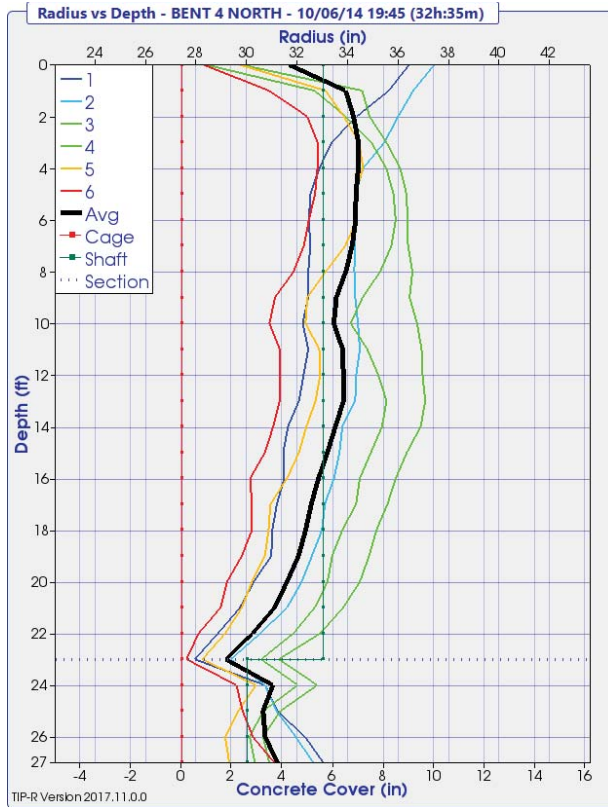
Figure 4. Radius vs. Depth Plot: Bent 4 North

The shafts were excavated and placed over a span of three consecutive days, with the concrete placement process occurring over the final two days. At Bent 4, the shafts were over-drilled by approximately seven feet and the reinforcing cages were suspended. Based on the shaft diameter and the magnitude of the over-drilling relative to the bottom of the instrumented reinforcing cage, there was no bottom roll-off evident in these shafts. For either TIP or CSL testing, meaningful analysis terminates at the bottom of the instrumented cage, limiting the results to this location. A representative model of the Effective Radius vs. Depth plot for Bent 4 is presented in Figure 4.

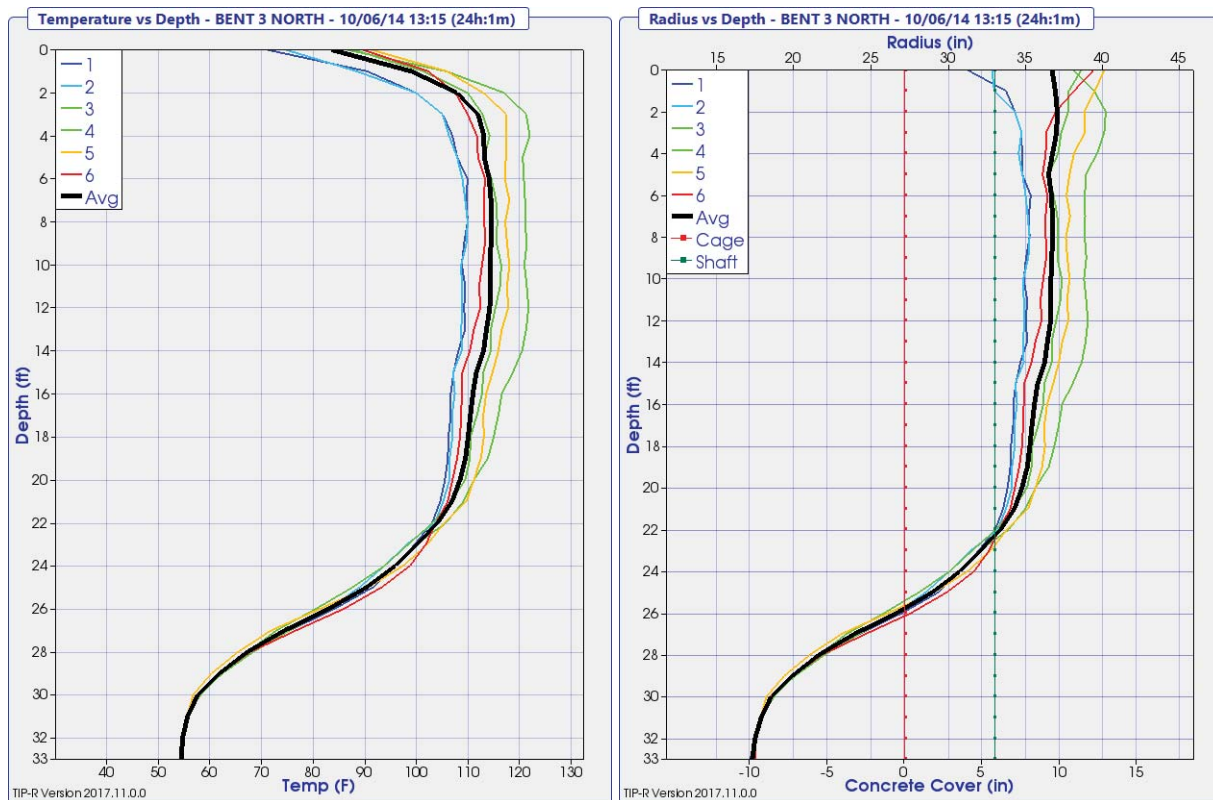
Figure 6. Temperature and Radius vs. Depth Plot: Bent 3 North

Due to inclement weather and construction sequencing issues, the excavations at Bent 3 were left open for more than a day prior to placement and were poured without a final cleanout. The TIP engineer performed a field review of the data the day after these shafts were drilled, which was indicative of a severe issue for both shafts. Figure 6 presents the temperature and radius vs. depth plot for a representative Bent 3 shaft. The bottom roll-off normally occurs within the lower one shaft diameter; in the case of this shaft a bottom roll-off is apparent beginning approximately 11 feet above the shaft toe. The temperature in the lower three feet of the cage is approximately equal to the soil temperature 24 hours after placement. The TIP radius versus depth model indicates a reduction in effective radius beginning at 22 feet below the shaft top, with the effective radius less than the cage radius at 26 feet. Shortly after placement of the shafts the final TIP results were presented to the engineer of record.

Overall, a distinct difference in the temperature profile was apparent between the shafts that were left open for days without a final cleanout versus that the shafts that were excavated and placed in the same day. It is likely that sediment built up over the course of a few days caused contamination or reduced quality concrete at the base of the shaft. A remediation plan was discussed and put into action before the shafts would have sufficient curing time for CSL testing. Ultimately, the Bent 3 shafts were replaced with driven piles.

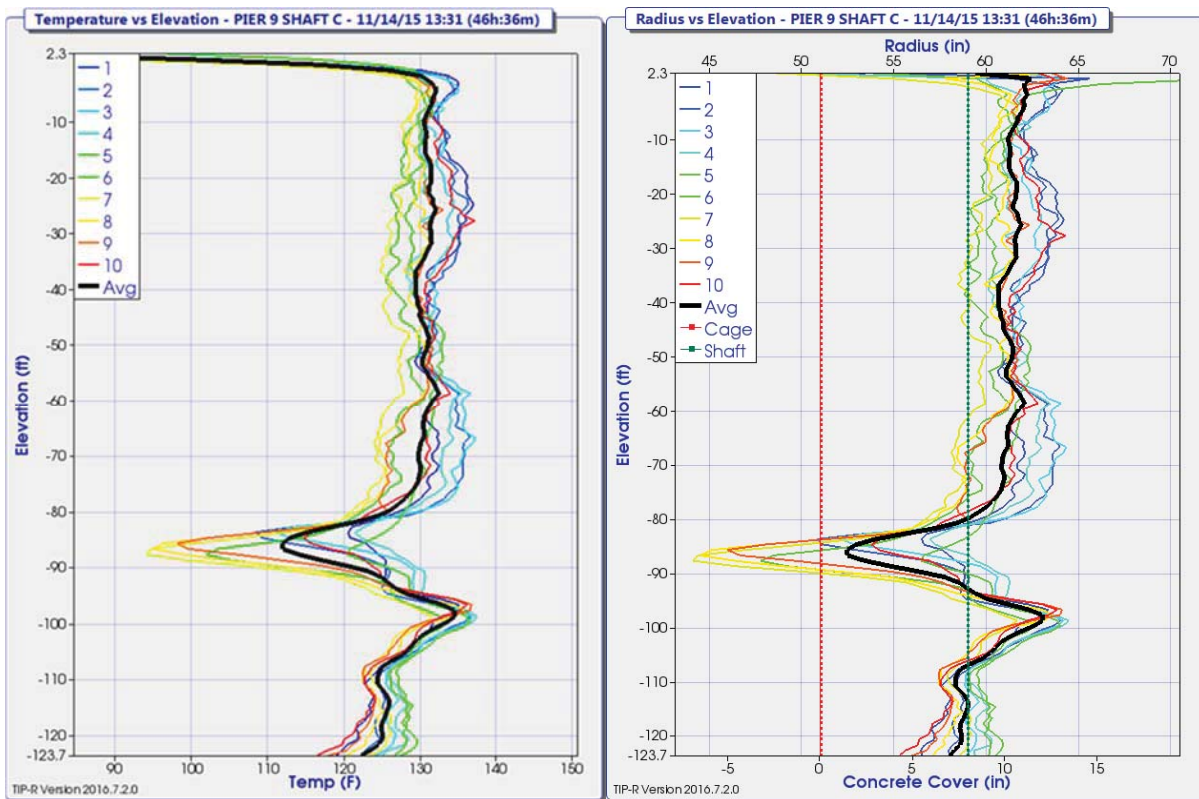
Figure 7. Temperature and Effective Radius vs. Elevation

The evaluation of the thermal results was based on data from 10 Thermal Wire® cables installed equidistantly around the reinforcing cage. Data was recorded from the beginning of concrete placement until peak temperature was reached approximately 46.5 hours after placement. The data was then downloaded for analysis. Figure 7 presents the Measured Temperature vs. Elevation and the Effective Average Radius vs. Elevation plot.

The temperature profile appears uniform from the top of the shaft down to EL-78 and from EL -105 to the base of the shaft. A significant reduction in temperature was observed from EL -80 to EL -95 which is indicative of reduction in the effective radius. While data from all 10 cables recorded a reduction in this region, the lowest recorded temperatures were near Wires 7, 8, and 9 where the local recorded temperatures were approximately 35 degrees Fahrenheit less than the average temperature of the shaft. Beginning at EL-78 the Effective Average Radius reduces down to 52 inches near EL-85.70. However, the Effective Local Radii for Wires 6, 7, 8, and 9 reduce to approximately 45 inches, which equates to no cover beyond the reinforcing cage in this region. An increase in cover or excess concrete is evidenced by higher recorded temperatures near EL-98.

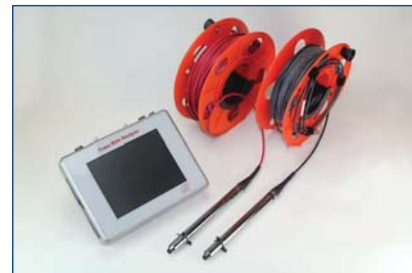
Cross Hole Sonic Logging

Plan view of shaft with 4 access tubes

Sonic Waves, emitted in one tube are received in another if concrete quality is satisfactory
