Corvallis Van Buren Bridge Replacement

Challenge:

The Corvallis Van Buren Bridge, originally constructed in 1913, underwent a replacement initiative to create an earthquake-ready bridge over the Willamette River on eastbound OR-34. Although the area near the bridge was used as a community dump site in the early 20th century, today this stretch of the Willamette River is a critical habitat for fish and other wildlife. It's also an environmentally attractive area with local recreational activities such as rowing and golf. To prepare for the new bridge, a comprehensive understanding of the soil and foundation was pertinent. GRL Engineers were hired to analyze the foundation's capacity, along with the construction quality of the project's drilled shafts.

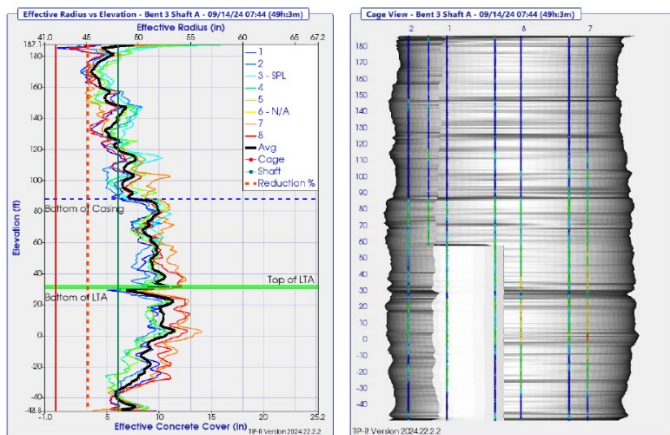
Figure 3 Estimated Effective Radius vs Depth Cage View

Based on the TIP results, the Effective Radius was generally consistent with the reported as-built shaft radii. The reported volume of concrete was 102 percent of the theoretical volume. Some of the wires in the cage did not function at all temperature nodes for the full duration of curing which made a complete interpretation of data difficult (Figure 3), thus the complementary value of the CSL testing was proven. The areas that were able to be assessed were rated as “Satisfactory”.

Thermal Wire[®] cables were installed on the reinforcing cage of the test shafts to help locate potential anomalies along the shaft length. The thermal data was analyzed approximately 2-3 days after concrete placement with [Thermal Integrity Profiling \(TIP\)](#).

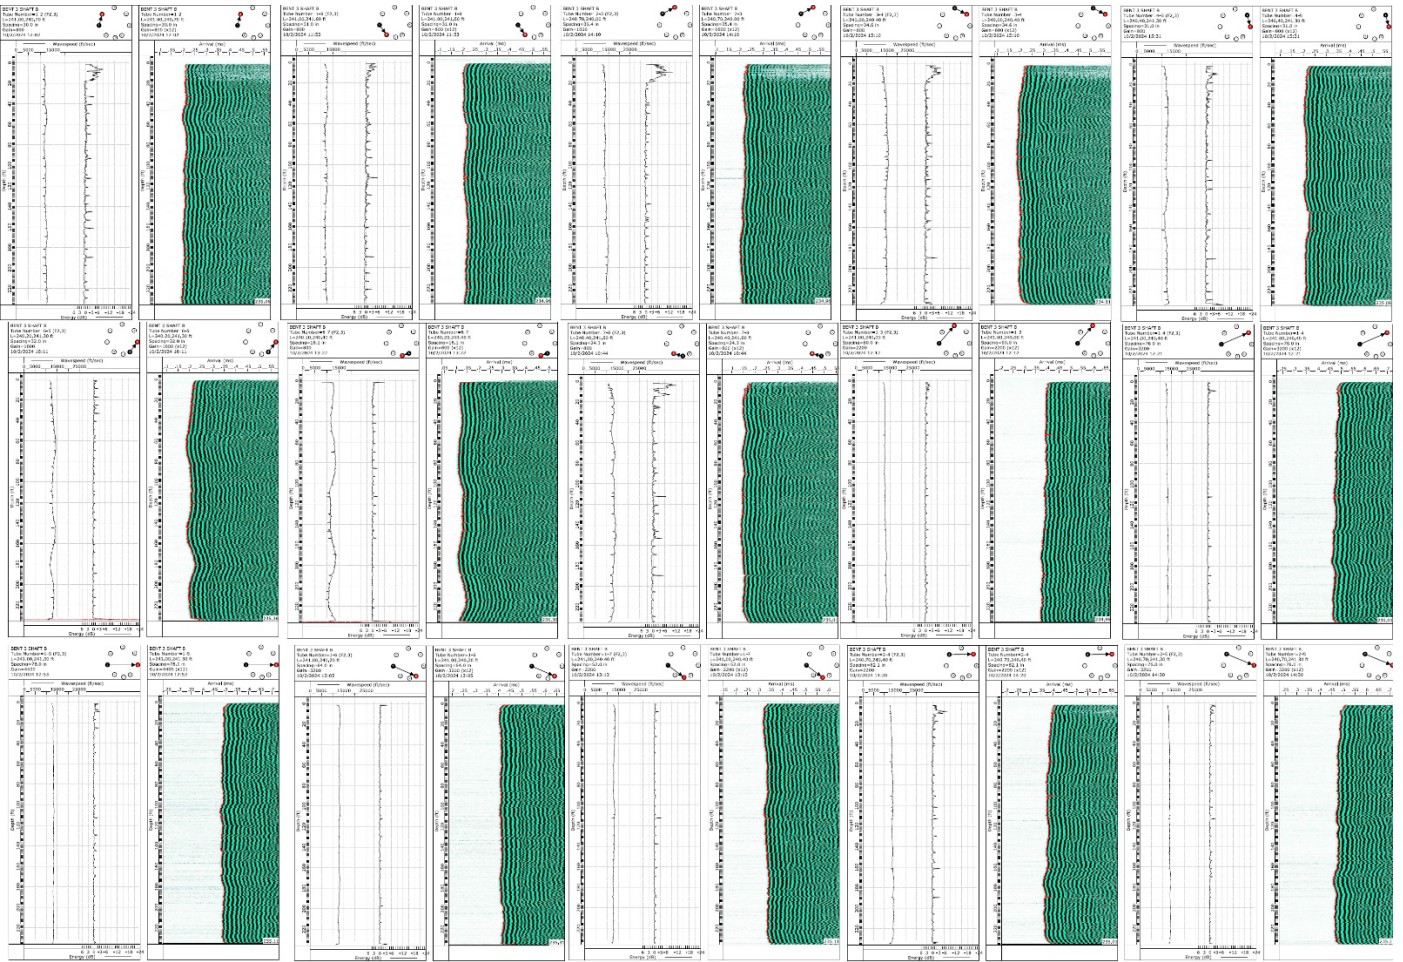
Figure 4 Sample of CSL Test Results

CSL results for the assessment of the relative concrete and shaft construction quality were considered within an acceptable range. (Figure 4) It was noted in the report that the Engineer of Record and Design Team would consider further assessment of an anomaly localized near one of the access tubes.

[Crosshole Sonic Logging \(CSL\)](#) was implemented on the project's 8 drilled shafts. The CSL testing was performed more than 3 or 4 days after concrete placement. Each tested shaft was approximately 8-feet in diameter with 8 steel access tubes of 1.5-inch diameter. A total of 28 CSL profiles were collected for each shaft.
